AVIATION INVESTIGATION REPORT

A00W0062

RUNWAY INCURSION

CALGARY INTERNATIONAL AIRPORT, ALBERTA

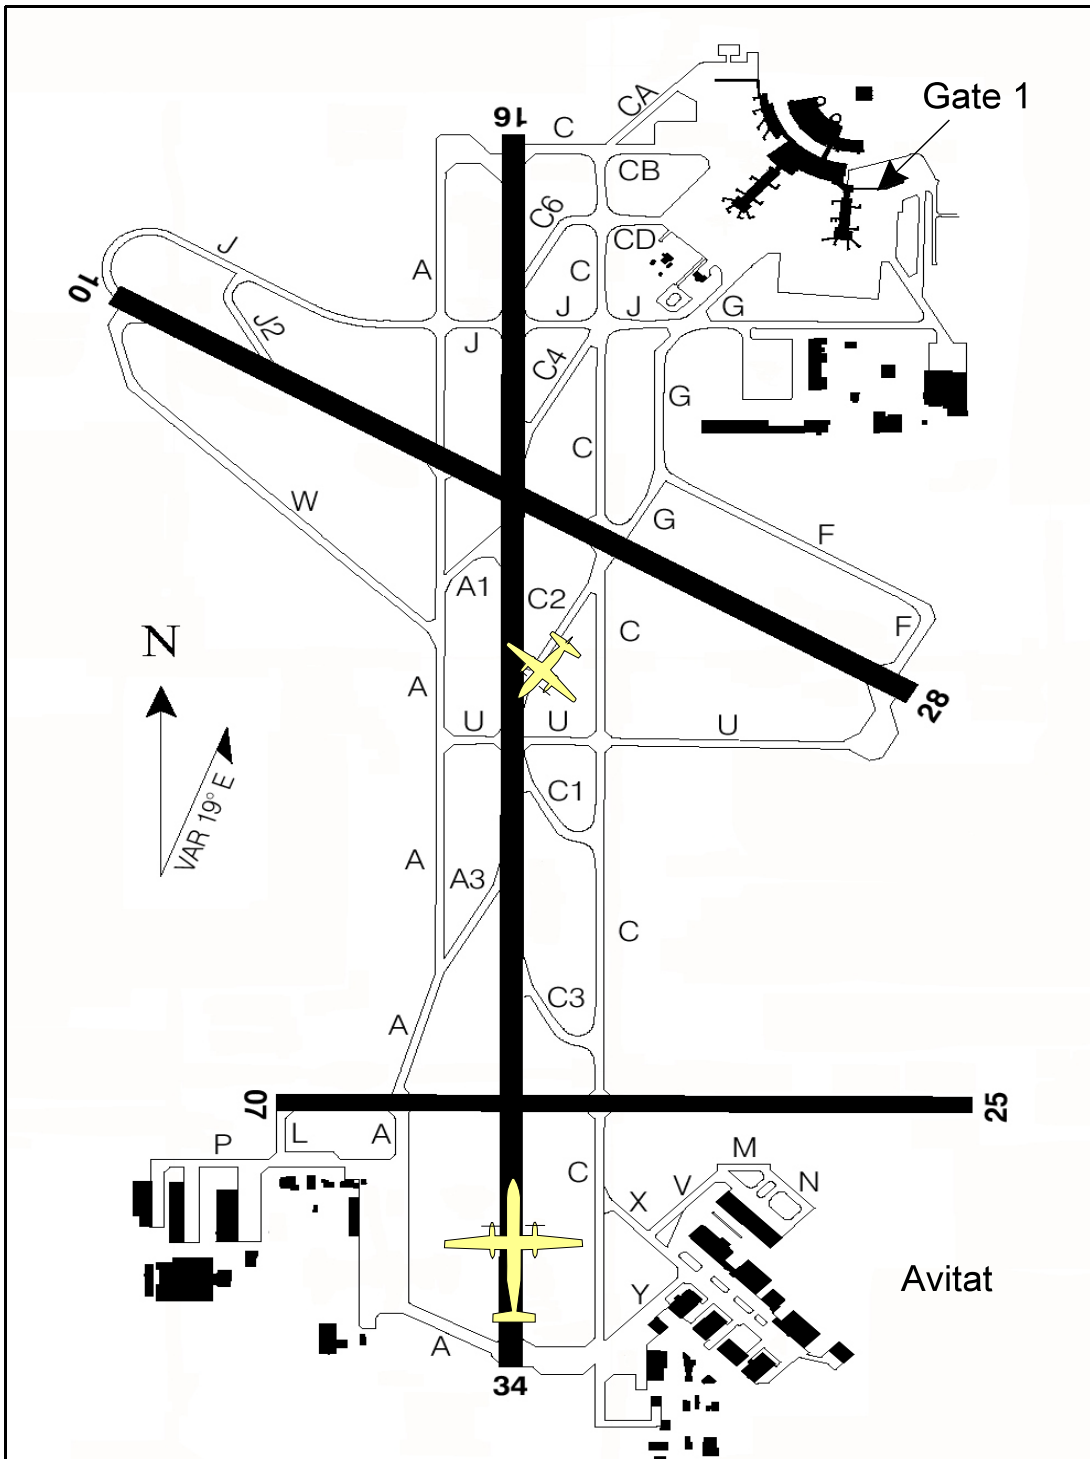
Appendix A - Airport Diagram and Aircraft Positions

and taxiway Charlie. Directly in line with taxiway Golf is the one-way taxiway Charlie 2 (see Appendix A). Taxiway Charlie 2 is one-way only, and is to be used as a runway exit by aircraft which have landed on runway 34. International do-not-enter signs are located at the east entrance to taxiway Charlie 2. The signs are illuminated, red and white, and made of reflective material. The area where taxiways Golf, Charlie, Charlie 2, and runway 10/28 converge was identified by some NAV CANADA and Calgary Airport Authority staff as being a known potential area of confusion, especially for crews not familiar with the airport layout. During the investigation, NAV CANADA and Calgary Airport Authority staff reported that there have been several incidents where aircraft instructed to taxi from Charlie 2 and Charlie northbound taxied from Charlie 2 onto Golf. Controllers also reported that they have provided direction to pilots who appear to be taxiing the wrong way but who, when reminded, can turn onto the correct taxiway without having to backtrack, due to the large paved area at the intersecting taxiways.
